RoodMicrotec
powerful solutions

Failure Mechanisms and Risk on LEDs and LED Systems

SMT 5.5. – 07.05.2015

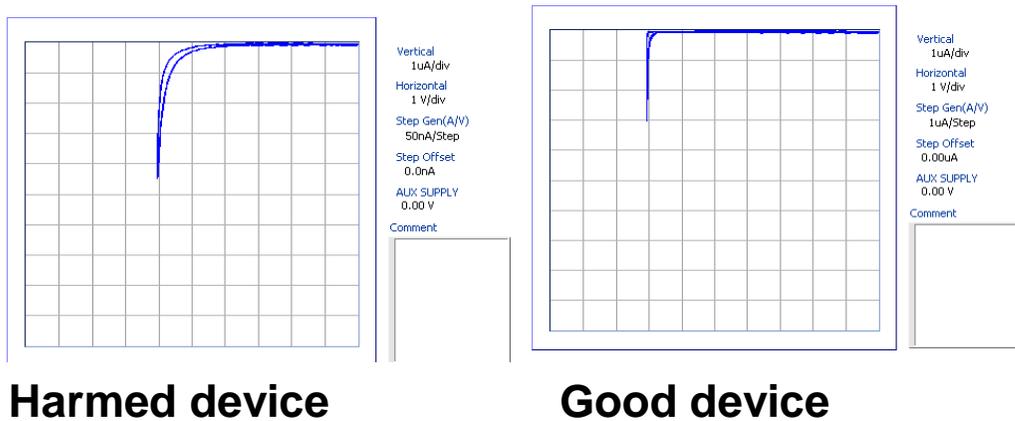
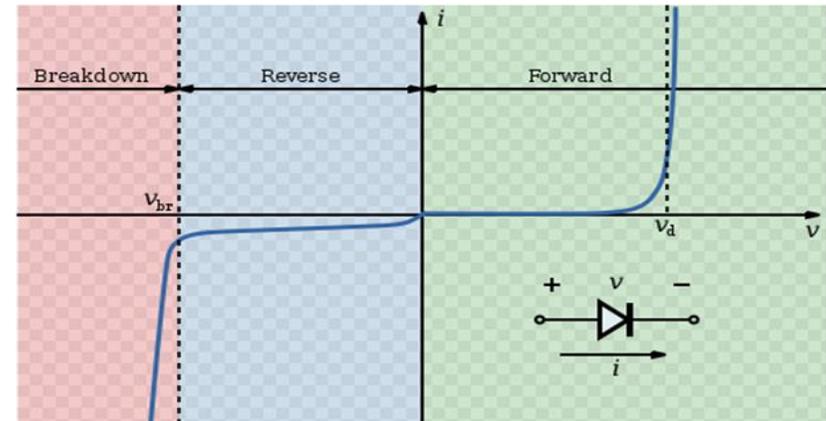
Increased reverse current, decreased break-down voltage
as a indication for impacts in the epitaxial layer system

Increased reverse current as indication for early failures

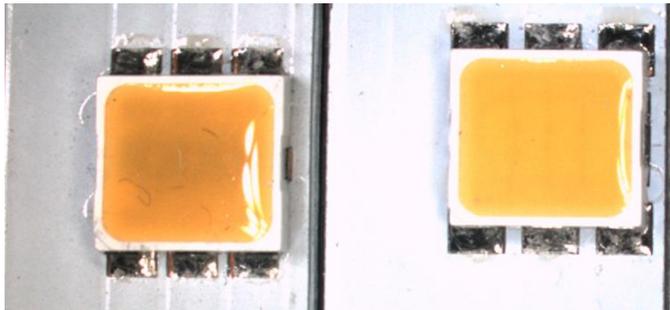
Failure after Life test 4000h and field failure

Field failure

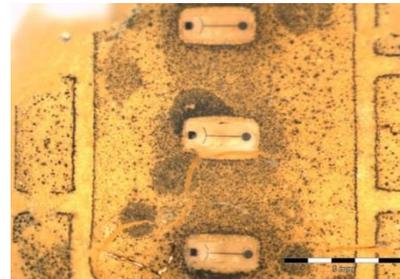
Die left at soft housing

Removal of encapsulant, chip stick at the housing material, die attachment insufficient

Package and interconnection material not sufficient

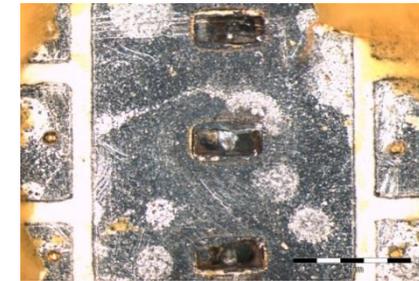
die imprints on submount

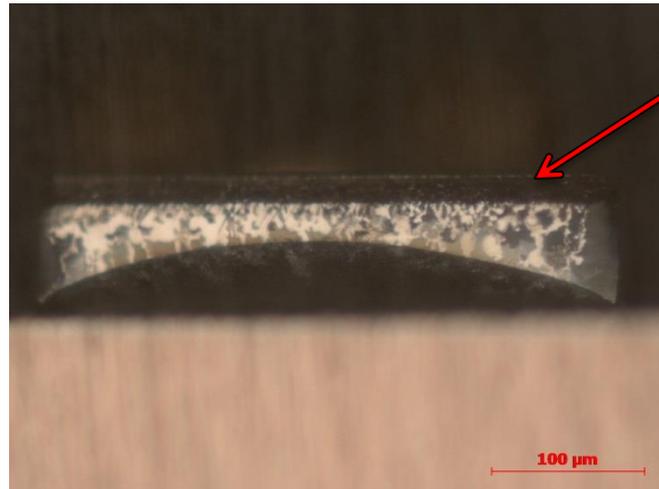
Silver-migration - short circuit / leakage only the green LED fails

Root cause: higher power consumption of the green LED results into an activation of a chemical reaction of glue thinner liquid with the Ag from the paddle

For the red LED the risk is also present – it will be a question of time until it fails.

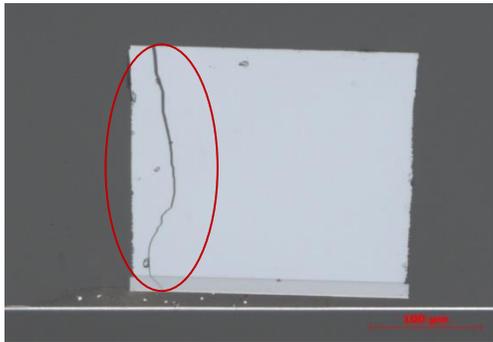
Crack in die due to insufficient die attach material and mechanical stress at placement

Solder material can not withstand the different thermal expansion of material used

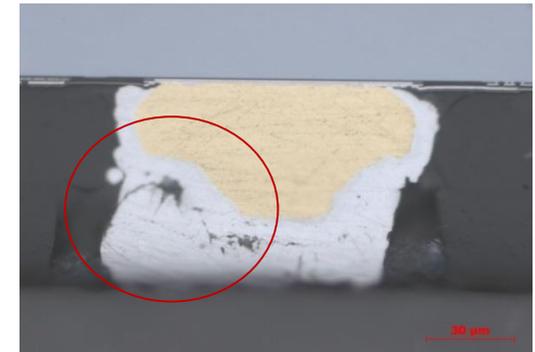
Mechanical stress by different thermal expansion coefficient and insufficient die attach

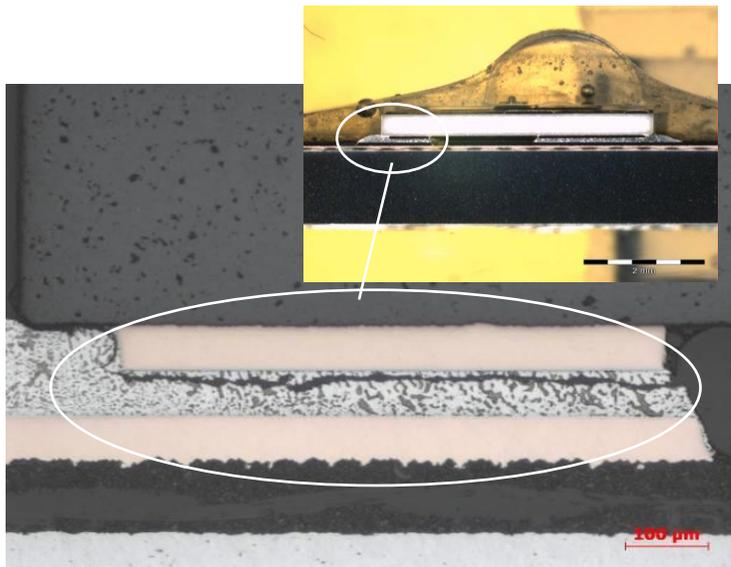
Solder joint between LED package and printed board open after 1000 temperature cycles

Cracks in solder joint

Thermal expansion of the different material not well matched

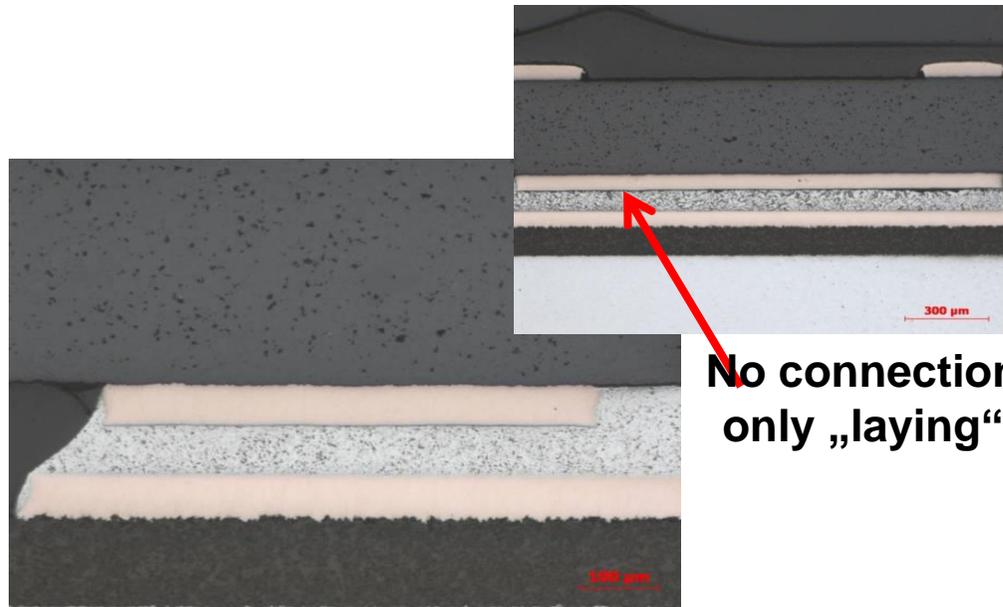
No connection
only „laying“

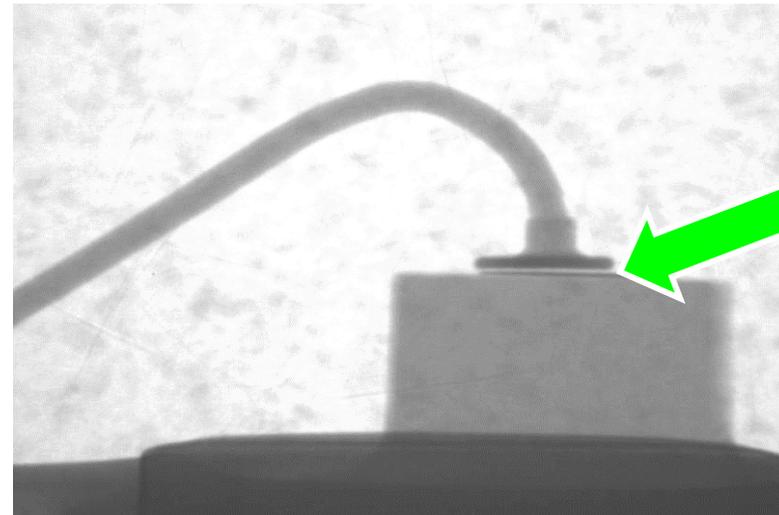
Damage by too high temperature during soldering process

Lift of the bond due to thermal stress during the

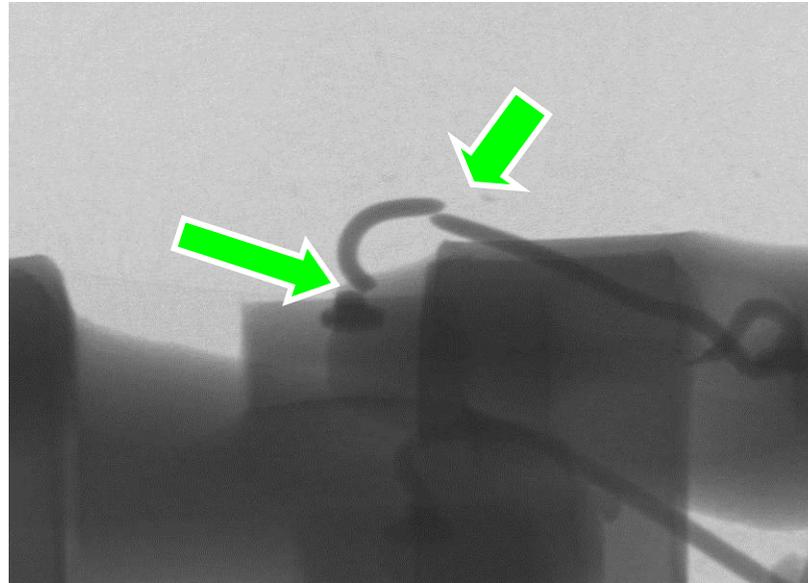
**Wire bond lift could be caused during
„pick and place“ process by a „sharp“ nozzle**

Mechanical deformation of the bond wires

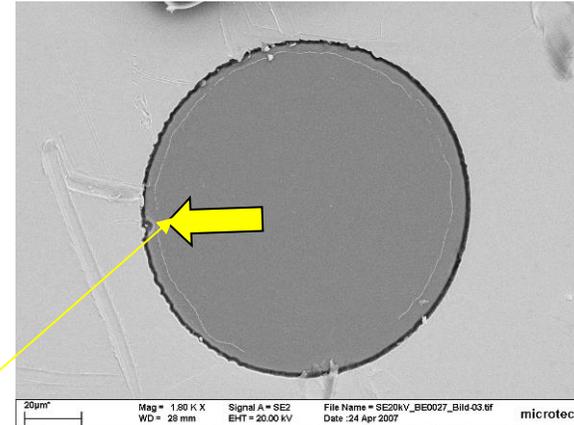
**Overview of lighting area:
Typical sign of a ESD damage**

**Complete shortage of the LED induced
by ESD damage**

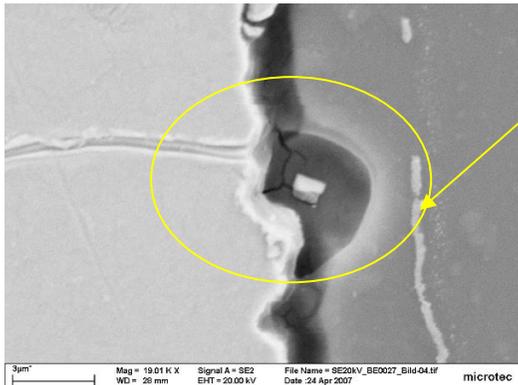
SEM analysis detail view of the damage

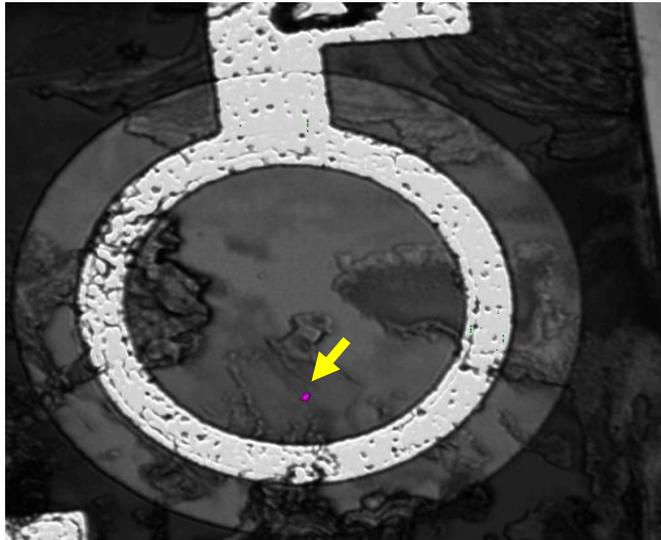
Reverse-leakage-current
detection by OBIRCH

**Lumen degradation induced by ESD damage: „Dark-spot“
Beginning of degradation**

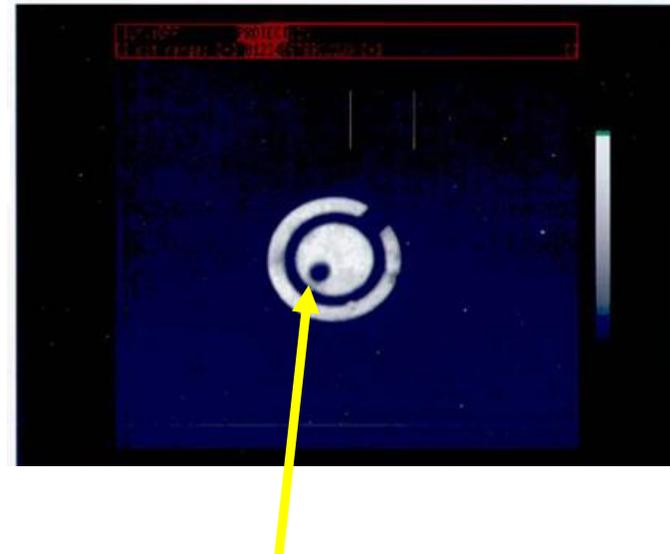
A large dark spot is already seen in
the driving mode. A starting point for
further degradation.

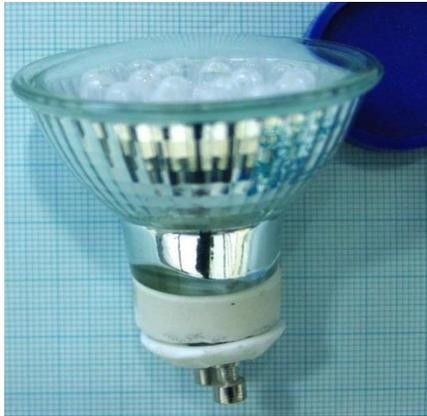
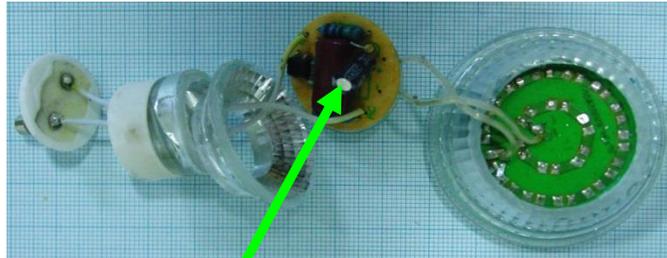
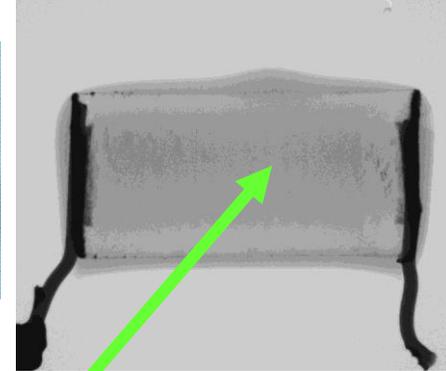
Defective tantal capacitor

Driving electronic failed due to Tantal capacitor
LED operates properly

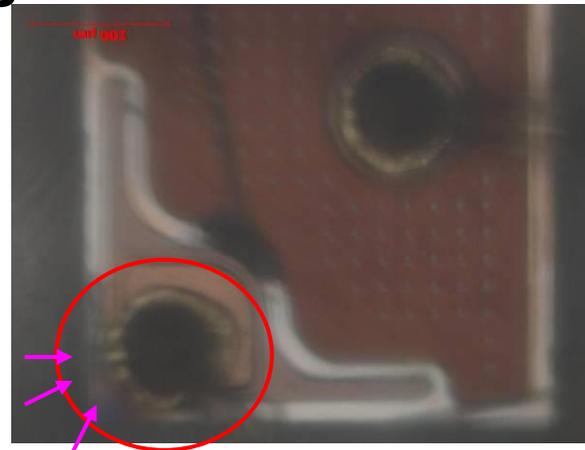
Massive damage in the bond area

Shortage induced by EOS

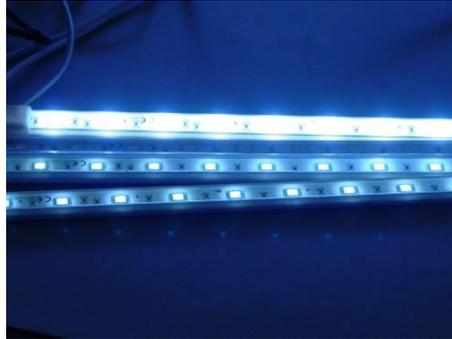
$T_{\text{case}} \approx 100^{\circ}\text{C}$
life time only few hours

$T_{\text{case}} \approx 42^{\circ}\text{C}$
life time ≈ 9.000 hours

LED light stripe: massive degradation due to insufficient thermal management

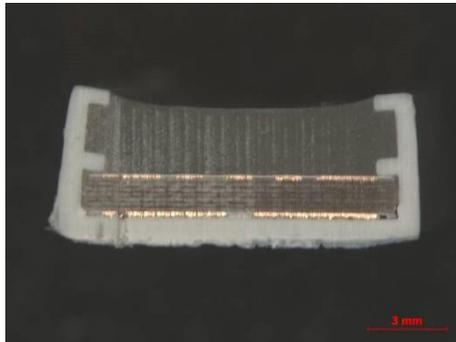
Plastic housing /FR4 printed board

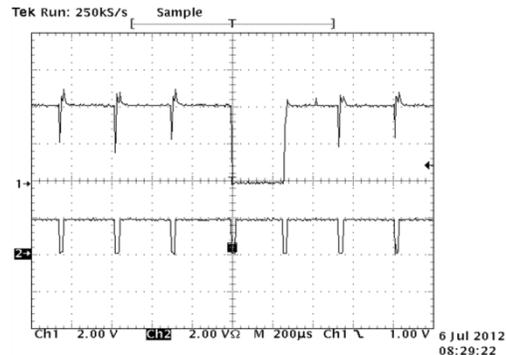
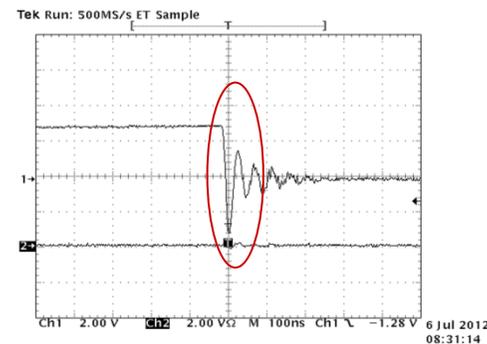
Previous circuit

“ spikes“ in the driving circuit reduce the lifetime of the LED drastically
Solution: serial diodes in both directions reduce the spikes drastically and increase the lifetime of the LEDs

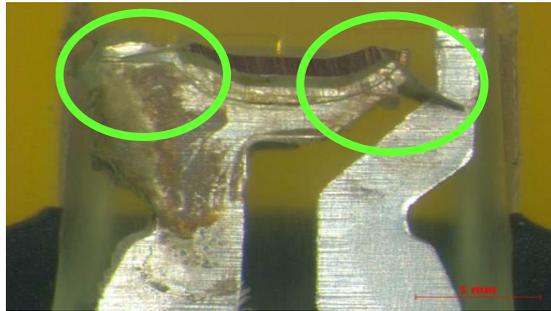
Silver migration and cracks

**Cracks and silver migration induced by the atmosphere
UV radiation, salty and humid atmosphere**

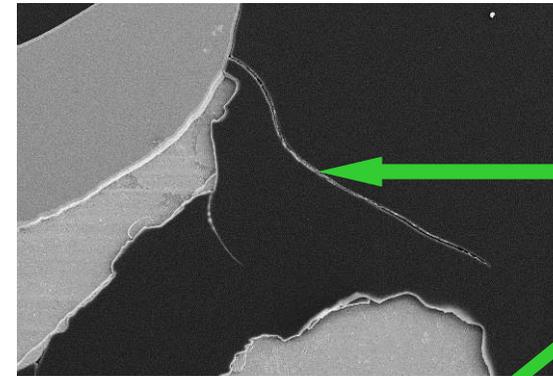
**Silver-migration
in the crack**

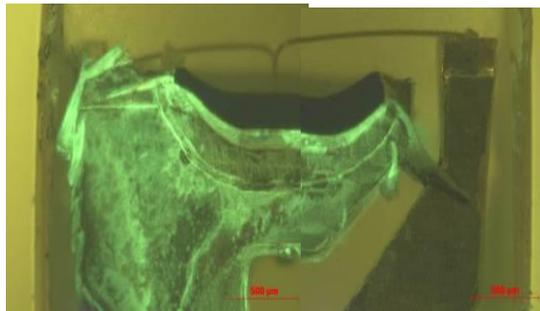
delamination detected by UV-light

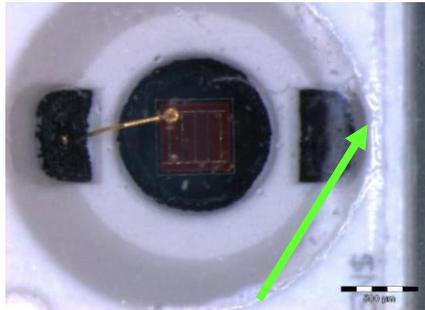
Silver sulfid

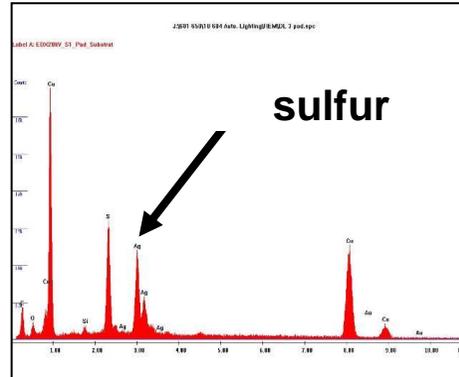
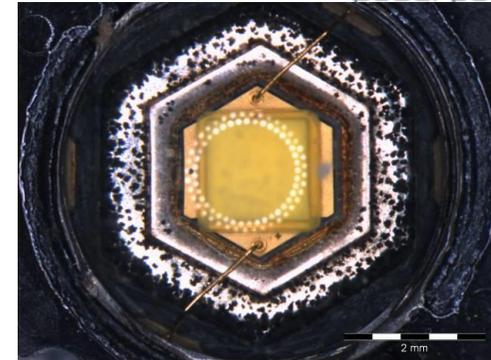
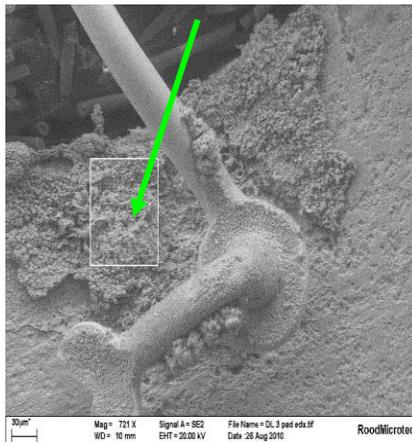
Silver-corrosion

- open circuit induced by aggressive atmosphere in the neighbourhood
- increasing of series resistance

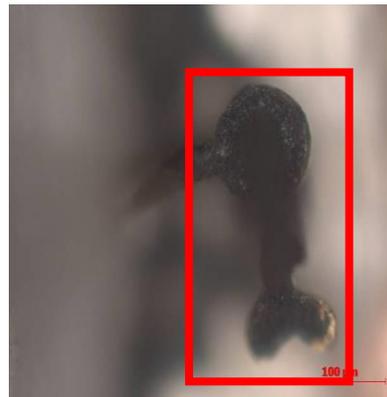
**Bond lifted from the
bondpad Silver corrosion
found under the pad.**

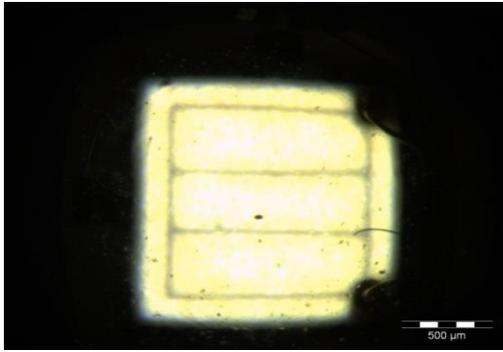
Delamination of Encapsulant Material: chip itself remains stable

Yellowing

Parameter	Average Change [%]
Popt	-8,4
Colour Coordinate x	10,8
Colour Coordinate y	20,1

Insufficient protection against aggressive atmosphere
