Down to the Wire

Failure Analysis Through the Cartesian Coordinate System

February 2022

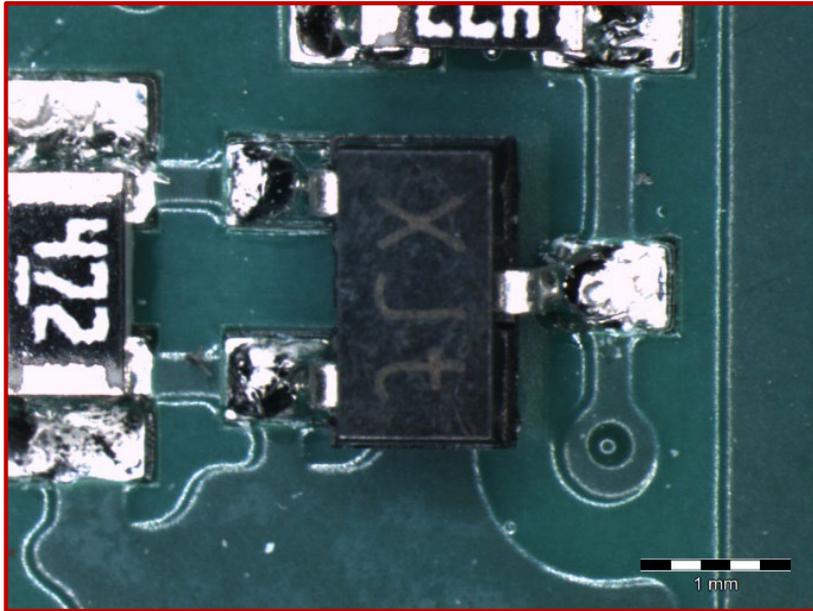
- ❑ Field failure in automotive application
- ❑ Malfunction on board level
- ❑ Failure could be explained with an open gate connection
- ❑ Only one failing part was available
- ❑ Desoldered after drying

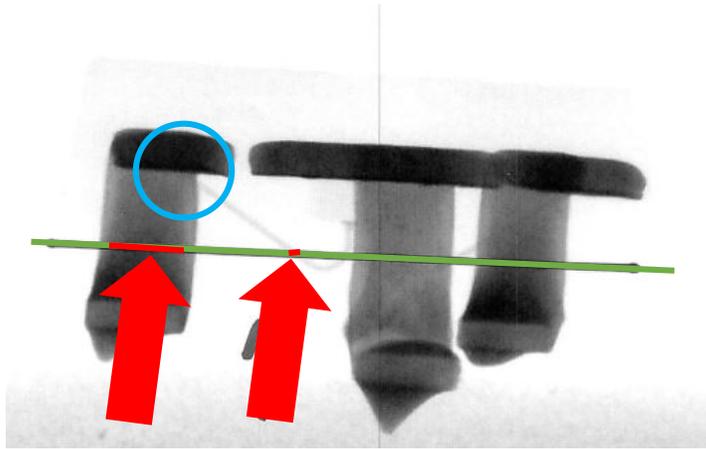
Failure Analysis – Y Cross Section

Flat grinding through PCB to interrupt bond loop.

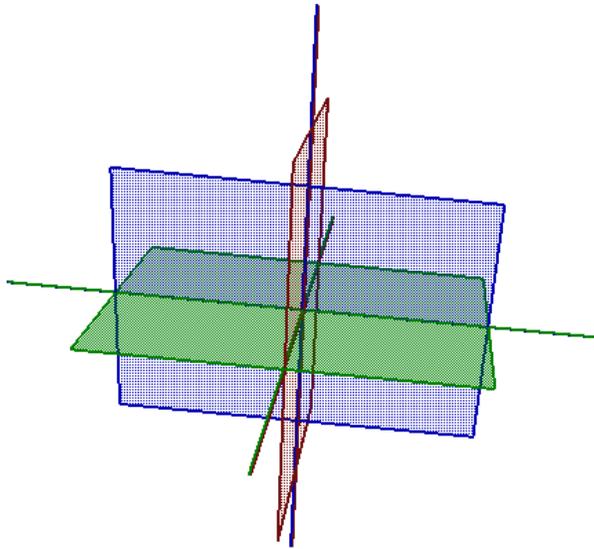
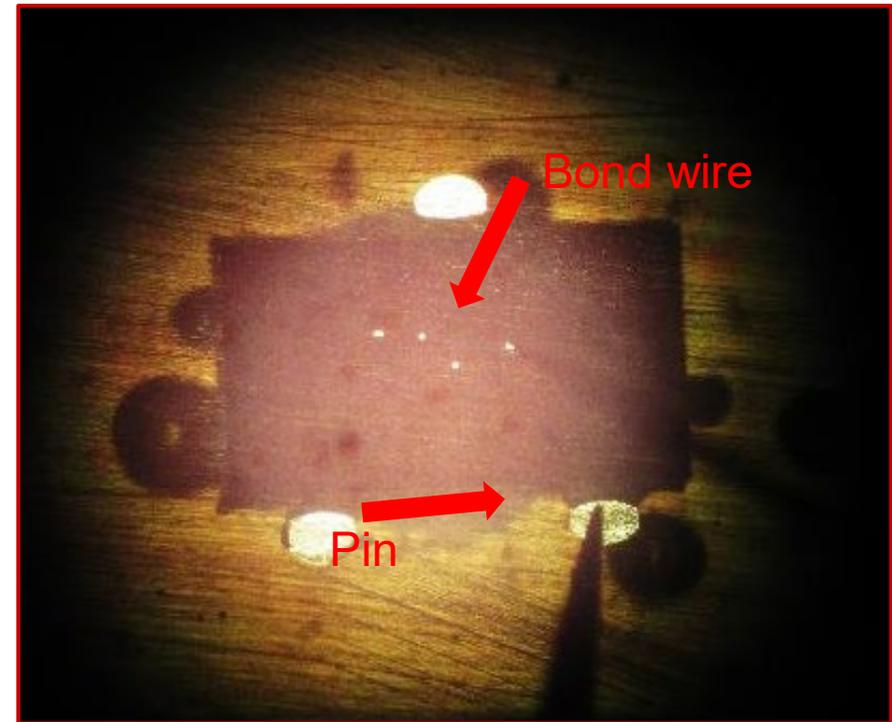
Resistance measurement with needle prober.

This confirmed an open connection on the stitch bond side.

Gate connection: 11.93 M Ω

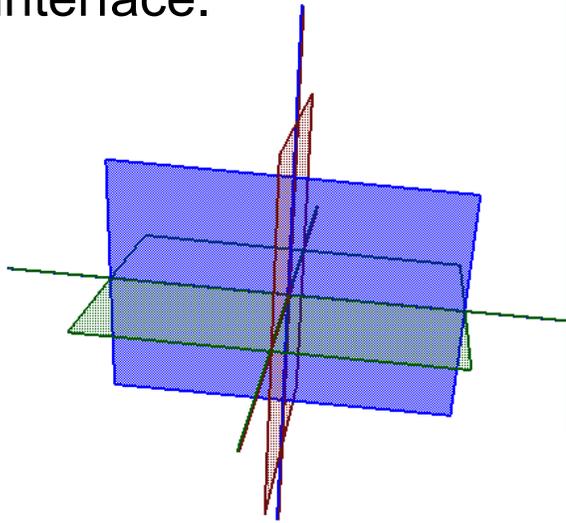
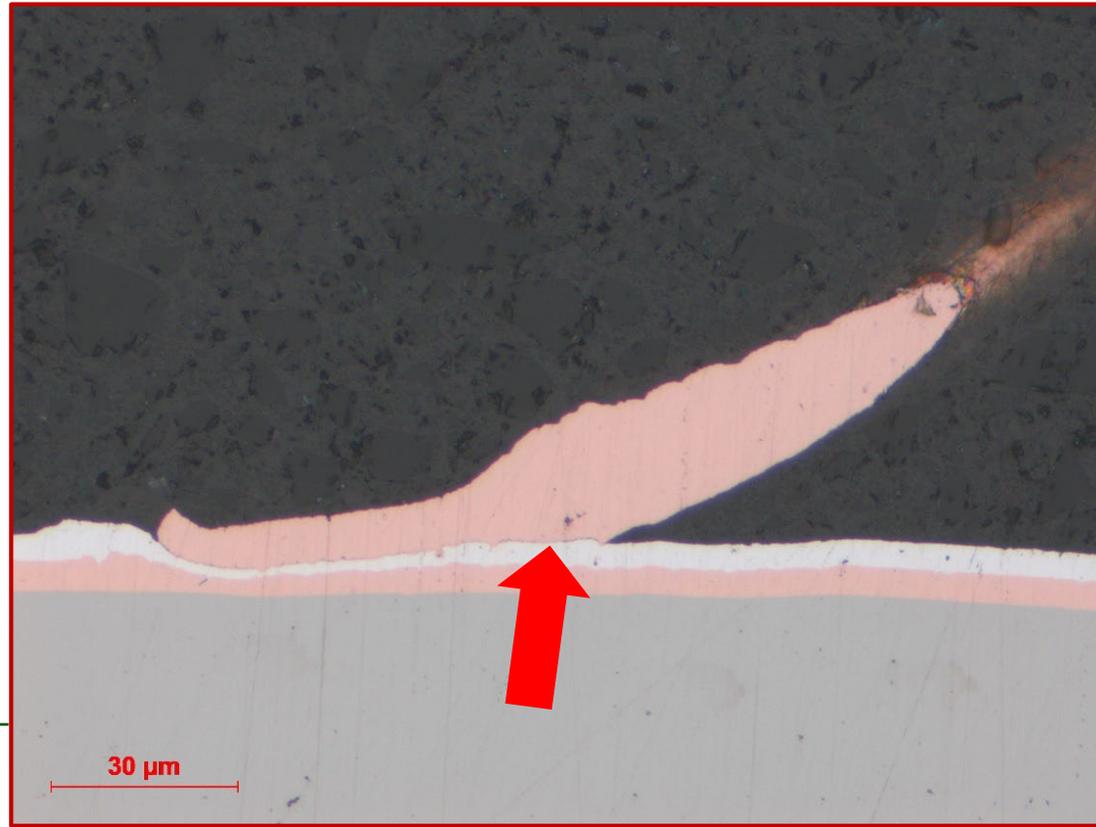
Failure Analysis – Z Cross Section

Cross sectioning through stitch bond. Showed signs of a black line at Cu-Ag interface.

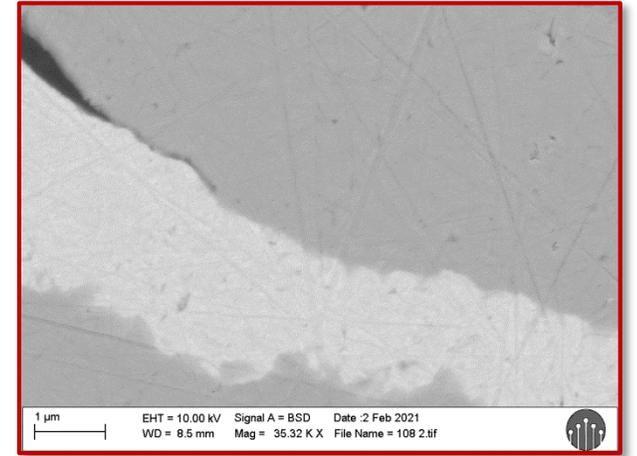
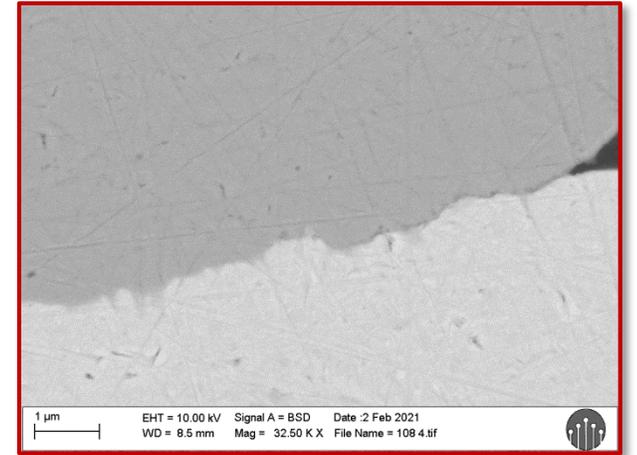
But not recognizable in SEM.

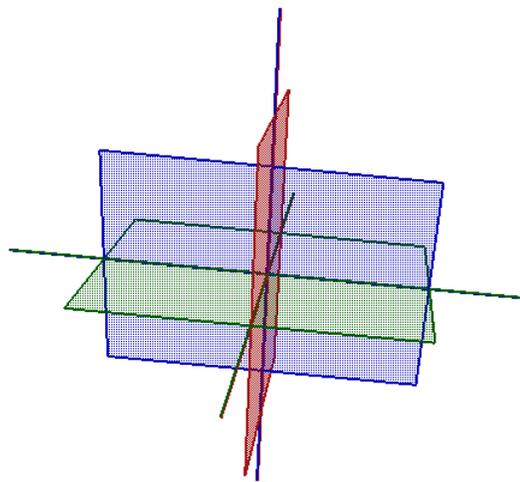
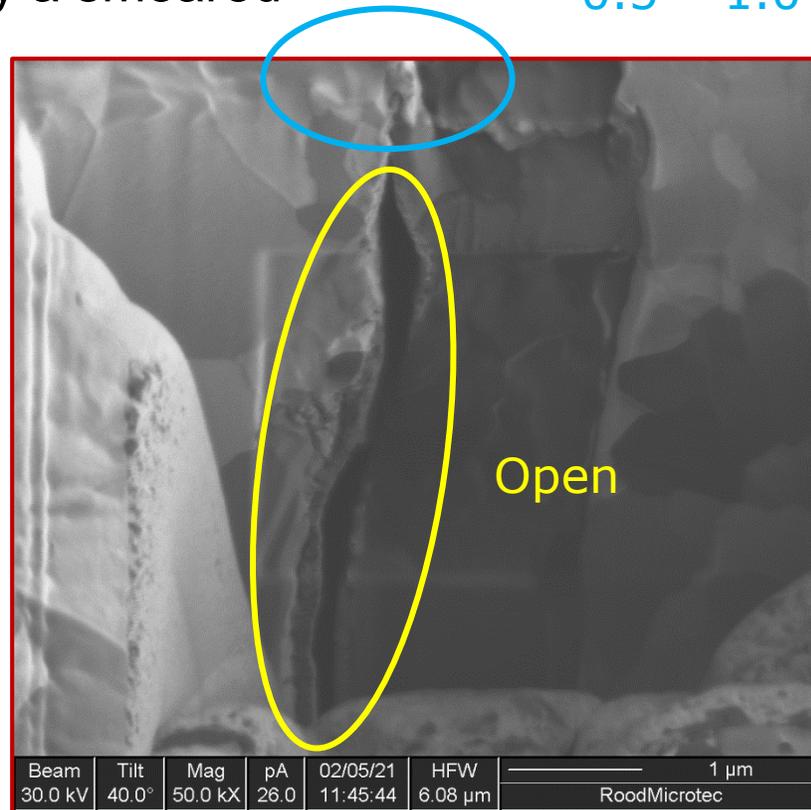
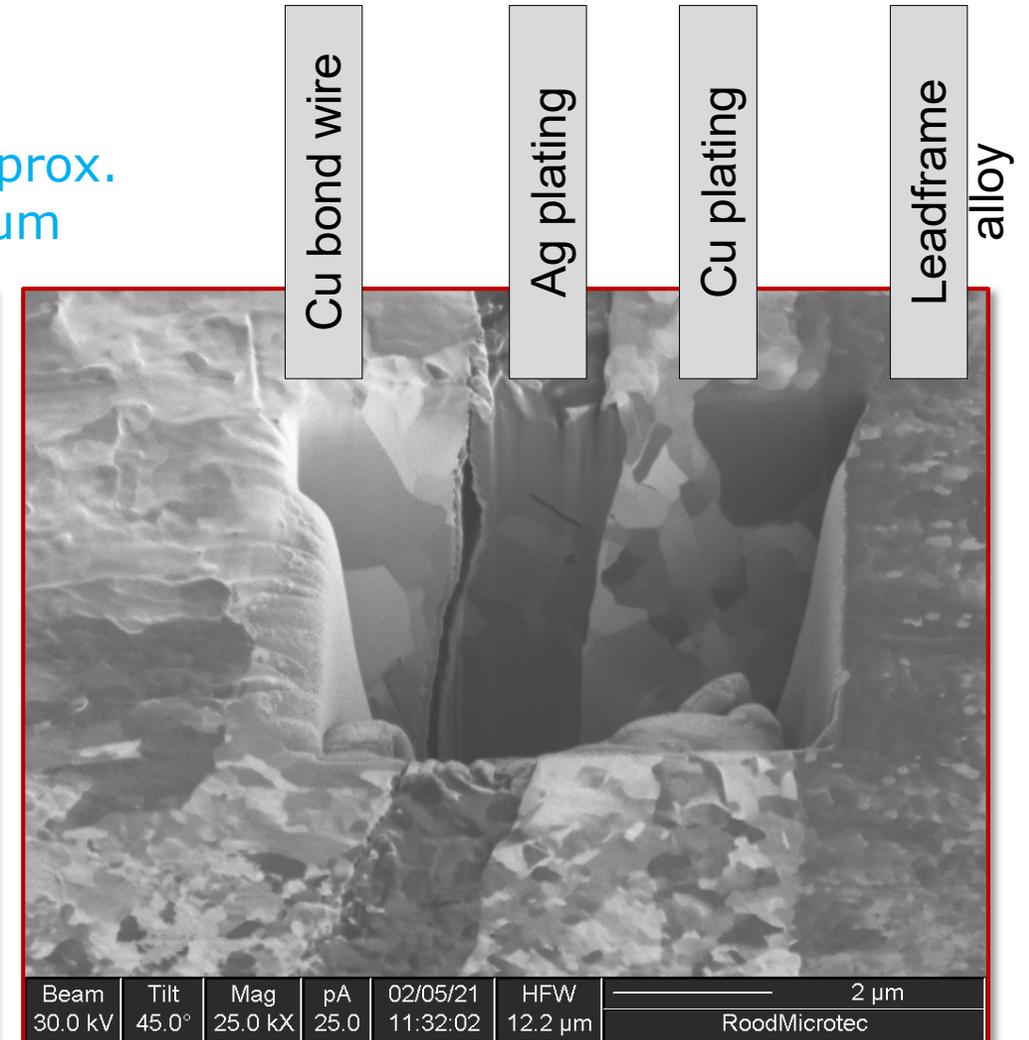
Failure Analysis – X Cross Section

Focus Ion Beam cross section through interface revealed an open connection covered by a smeared surface.

Smearing approx.
0.5 – 1.0 μm

- ❑ Machine polishing can induce a smearing of approx. 0.5 – 1.0 µm.
- ❑ FIB cross section have become increasingly necessary to confirm such open bond contacts.
- ❑ Automotive failure analysis often require extra steps, both in between and at the end to conclusively confirm the physical failure without losing it, especially when only one failed part is available.
