**Multi Layer Ceramic
Capacitors (MLCC)
one of the most
mechanical sensitive
component**

What is a Multi Layer Ceramic Capacitor (MLCC)?

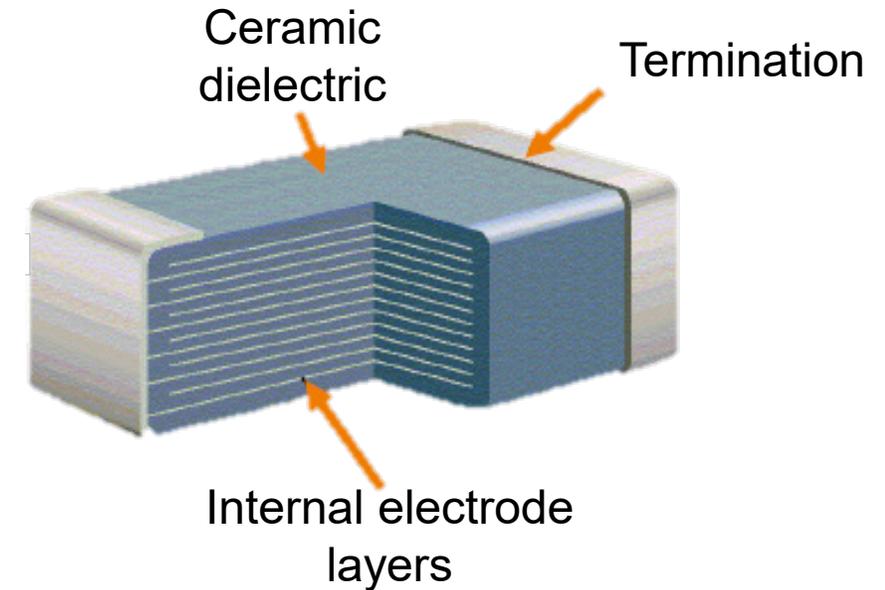
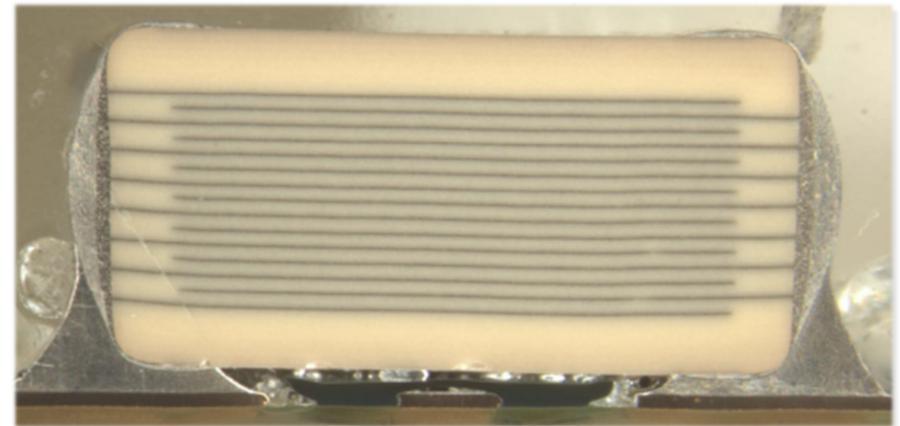
■ Structure

- Ceramic block
- Embedded metal layers
- Termination on both sides

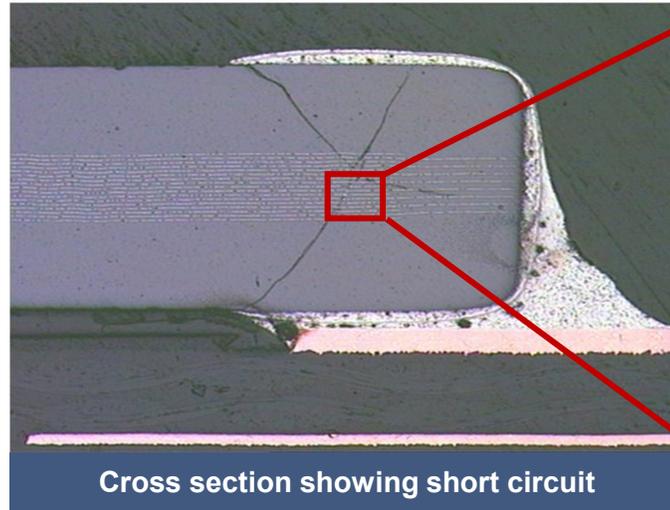
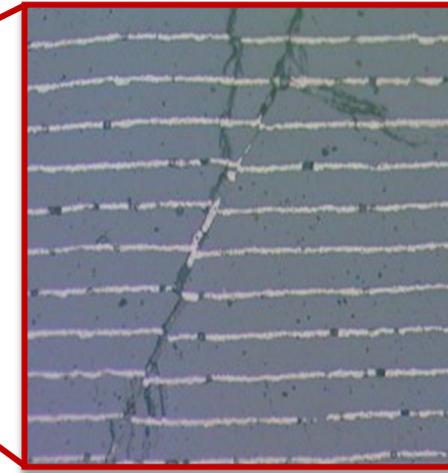
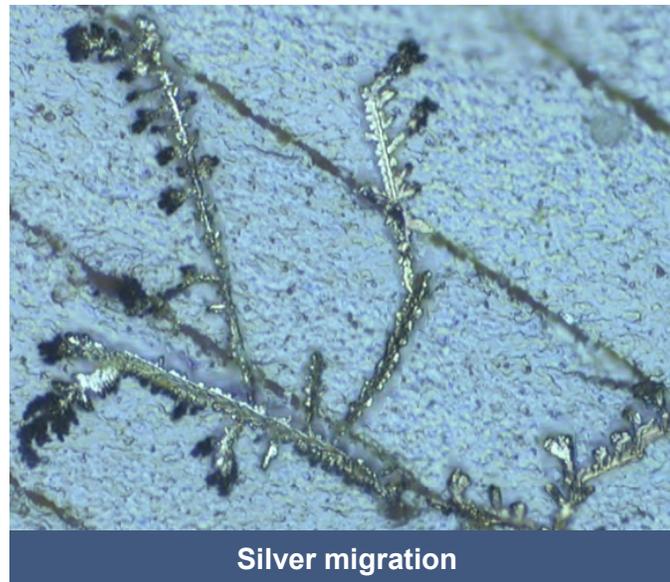
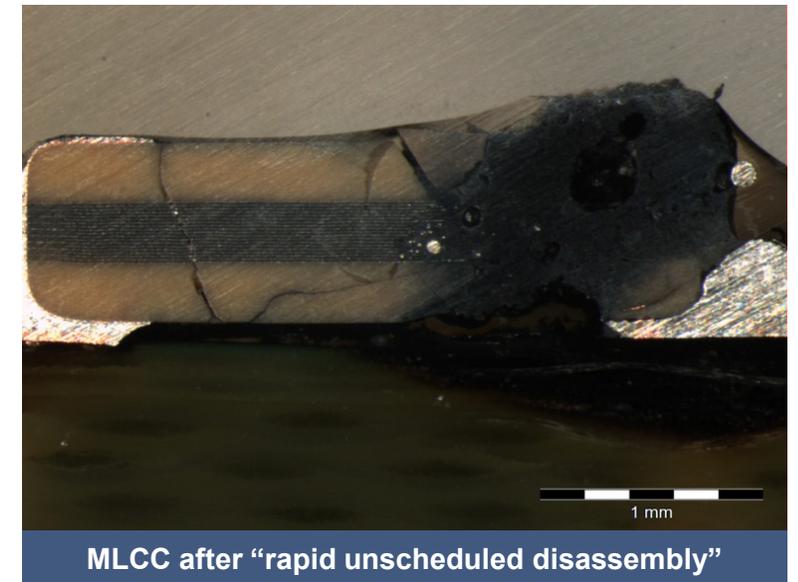
Migration and dendrite growth

- Cracked capacitors are hardly detectable within outgoing inspection
- Silver migration or dendrite formation through the crack resulting in an electrical short circuit
- Approximately after 6 to 24 months in the field the assemblies fail with burned capacitors due to electrical shorts between capacitor plates

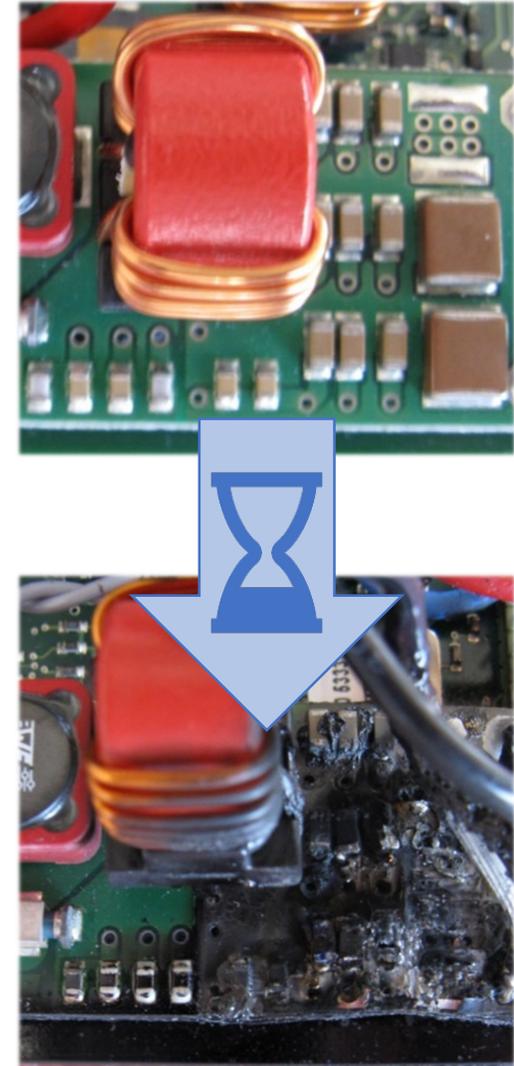
- ~ 90 % of MLCC field failures are caused by mechanical overstress, resulting in so called „Flex Cracks“
 - Critical processes are component assembly, assembly of press-fit components, singulation of multi panels and assembly in the system
 - High mechanical stresses occur at the edge of the printed circuit board (recommended distance greater than 5 mm), close to press-fit connectors, near large components and close to (screw) mounting points. These places are to be avoided.
 - **Electrical board tests detects roughly 1% of the cracked devices**
 - **Not visible by optical inspection**
- Electrical Damage
- Manufacturing defects

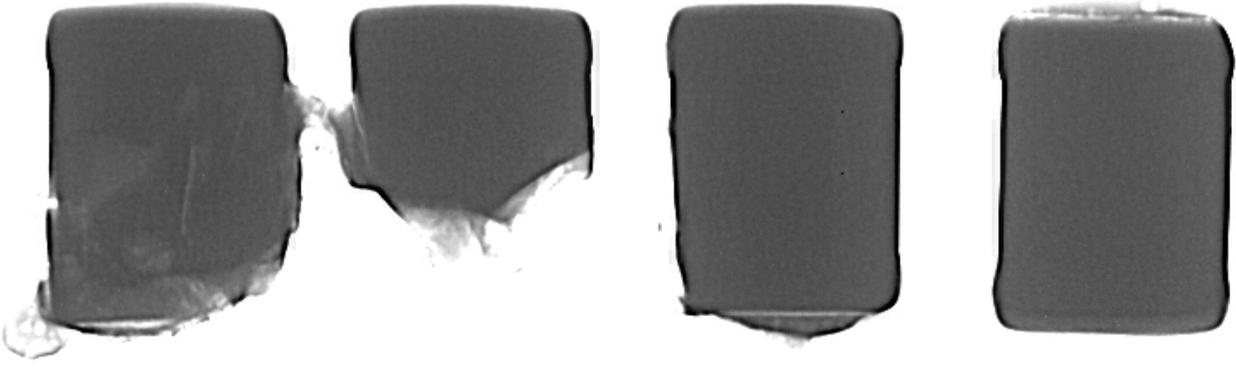
X-Ray microscopy of ceramic capacitors

- Capacitors 1 and 2 are more than obviously broken, but 3 and especially 4 look relatively inconspicuous on X-ray
- Cross sections revealed massive damage (electrical as well as mechanical) of capacitor 3
- Capacitor 4 has no visible damage (in this cross section plane)

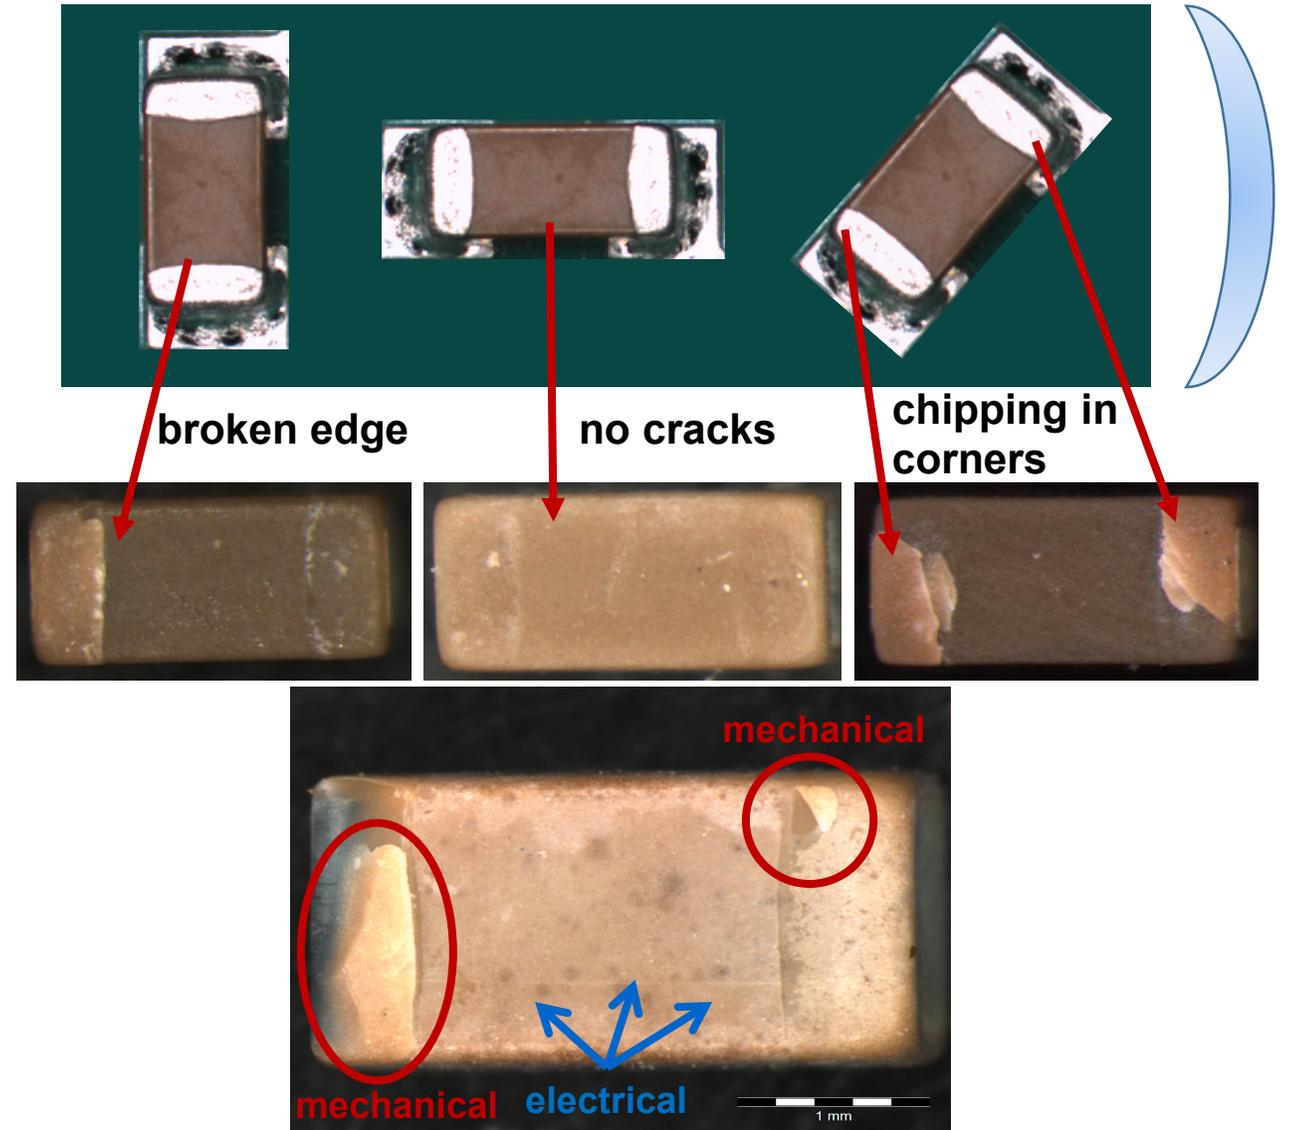
Optical inspection after removal of the terminal metallization

- Less time consuming compared to cross sectioning
- Position of crack(s) is visible
 - The fracture pattern is depending on the course of the bend relative to the orientation of the ceramic capacitor
 - Torsion?
 - Bending (-direction)?
- Electrical damage visible
- If the capacitor is mounted, thermal and mechanical stress can occur due to desoldering

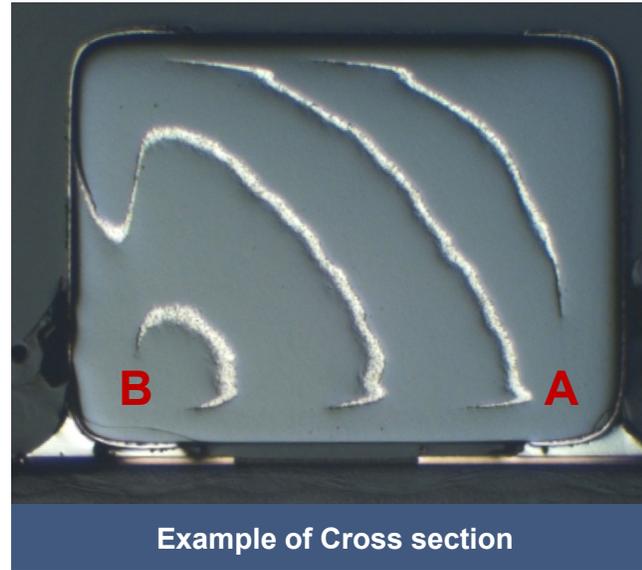
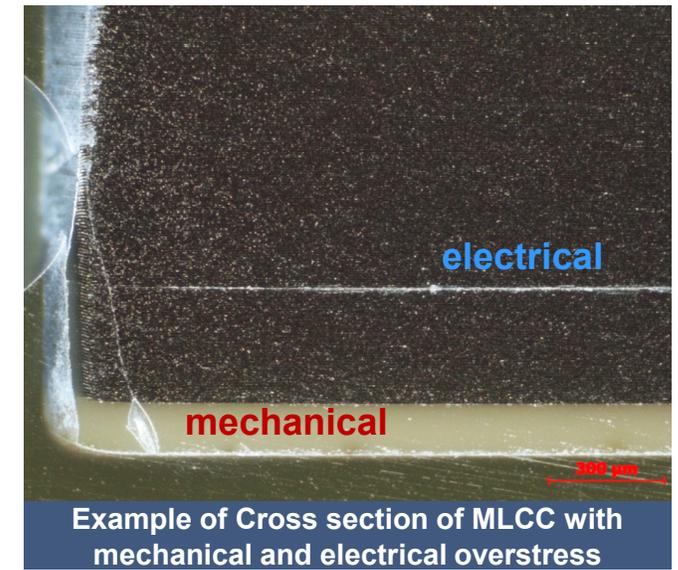
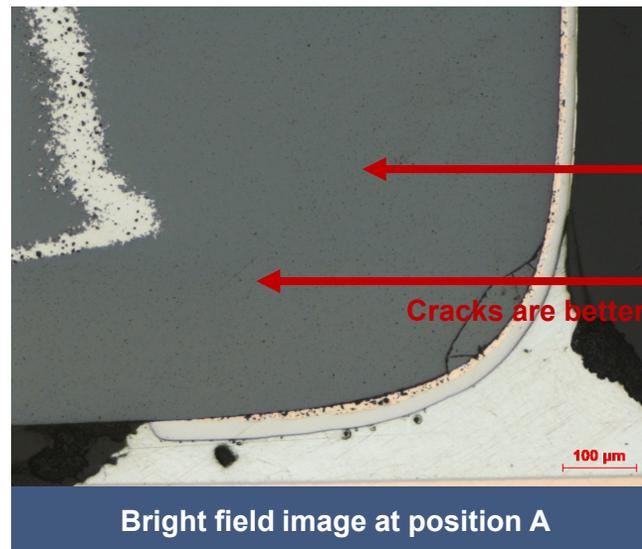
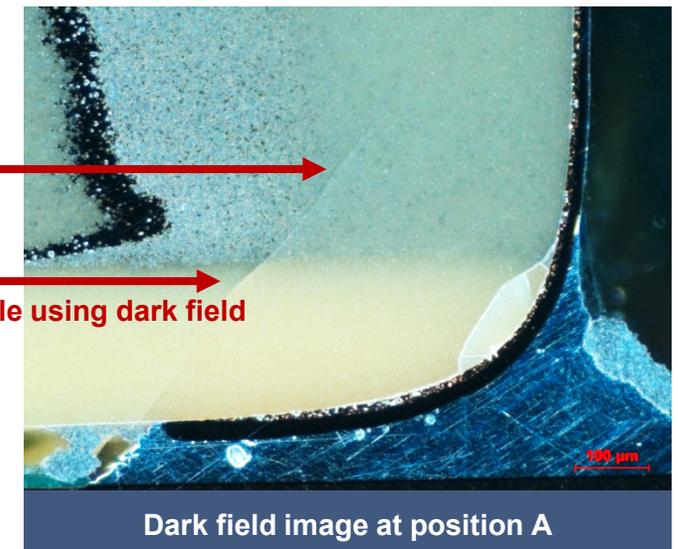
Metallographic Cross Sectioning

- Cracks within the capacitor visible
 - Starting at the edge of the solder joint
 - The crack path is always inclined towards cap
 - The crack always continues towards the terminal
- Electrical monitoring during grinding possible
- Electrical damage clearly visible (crack along plates)
- Manufacturing defects visible (e.g. missing plates)

Cracks are better visible using dark field

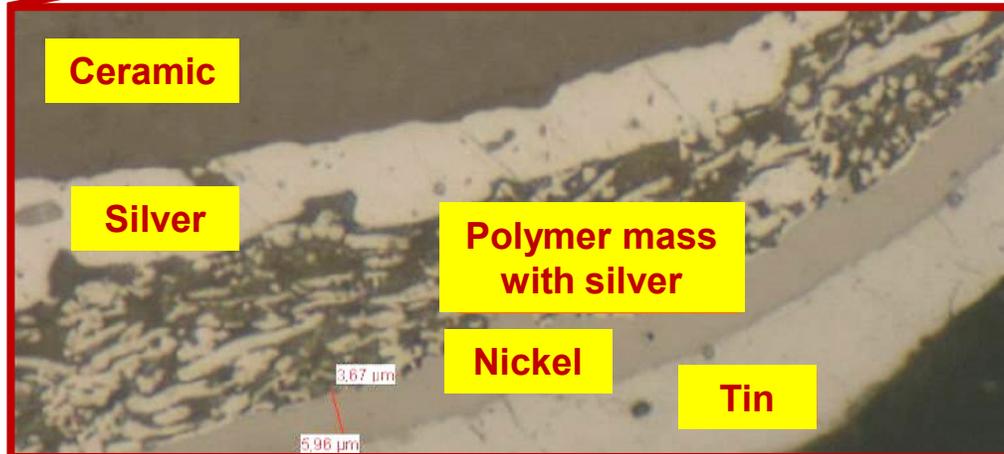
- Flex cap – avoid the crack
 - Silver-filled polymer mass between silver terminal and nickel-tin layer compensates for mechanical forces

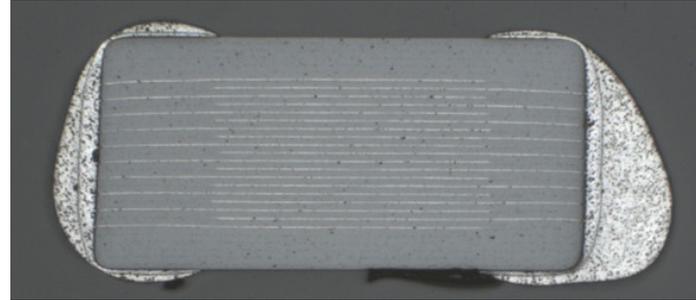
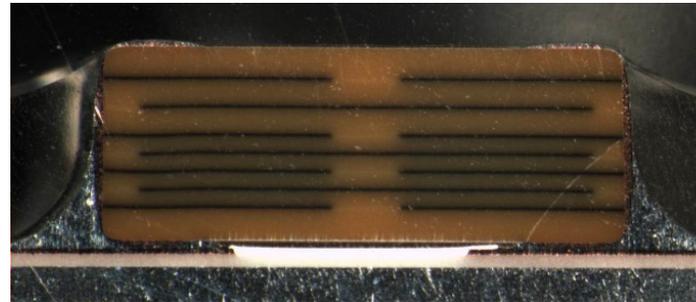
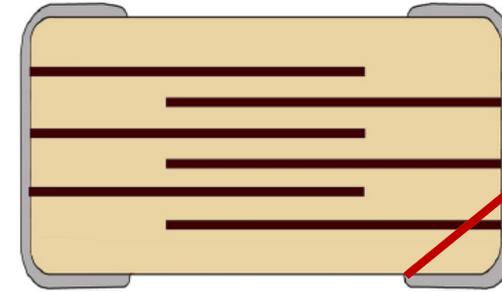
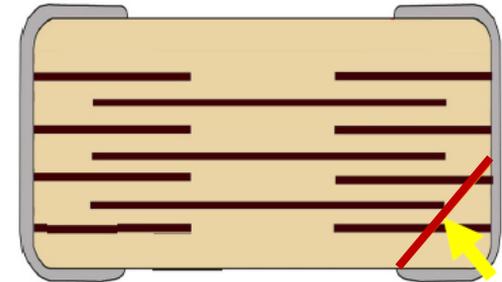
- Fail safe capacitors

- *Fail open type* - no overlap of the electrodes in the terminal area
- *Floating center plates* - no short circuit between the two component connections possible

- Serial connection of two capacitors

- No hard short circuit if one capacitor fails
